XPR LAGUNA SOUND

Extreme polymer rigid core waterproof

XPR + PAD

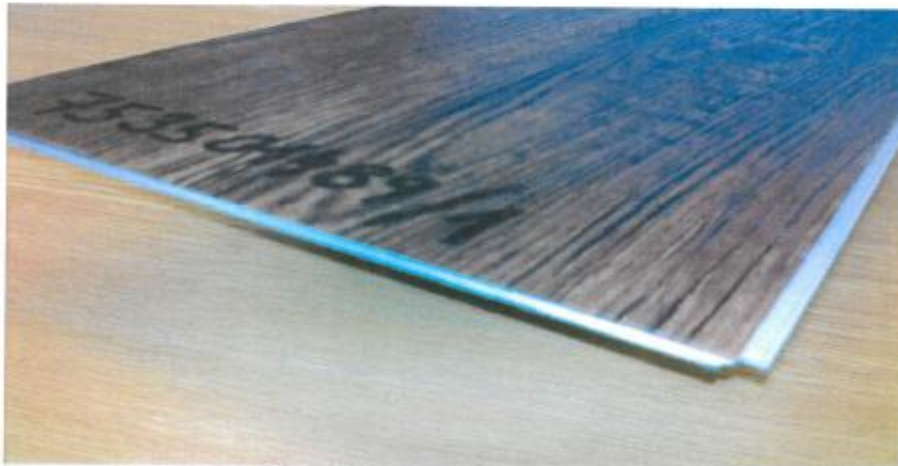
Sample photo:

- Wear layer: 0.5 mm (PVC)
- Base layer: 3.85 mm (PVC)
- Balance layer: 0.65 mm (PVC)

Total thickness (wear layer thickness): 5.0 mm (0.5 mm)
 Laying way: click, loose (no adhesive)

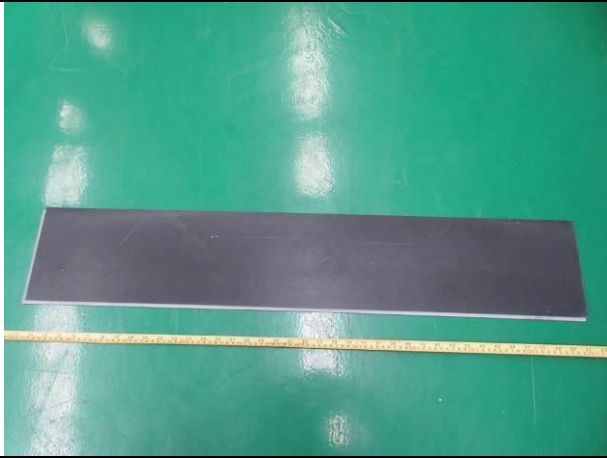
A photograph showing the back of the sample, which is a dark, solid color. A yellow measuring tape is placed horizontally below the sample for scale.
<p>C.1 Surface view of sample</p>	<p>C.2 Back view of sample</p>
